## Section Inspection - 12/12/2025 - 1/1 - 2/1

| Project name<br><small>SEE Civil - Box Culvert - MARINE PARADE - 12-12-2025 - Float works</small> | Contractor's Job Number | Coding Standard<br><b>WSA 05-2020</b> | Name of operator<br><b>Shane Holmes</b> | Job ID<br><b>01</b> |

| Profile<br><b>Rectangular 1200/2700mm</b> | Purpose of inspection<br><b>New construction</b> | |

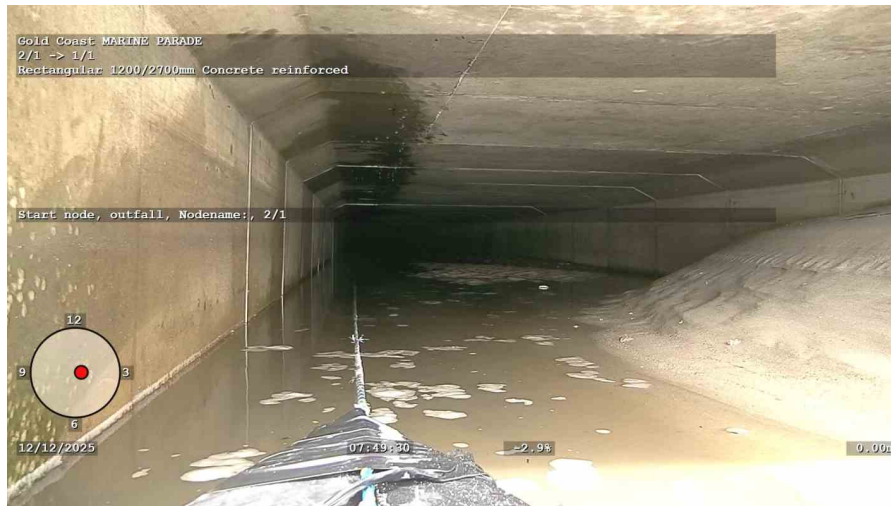
1, 00:00:11, 0.00  
 Start node, outfall, Nodename:, 2/1

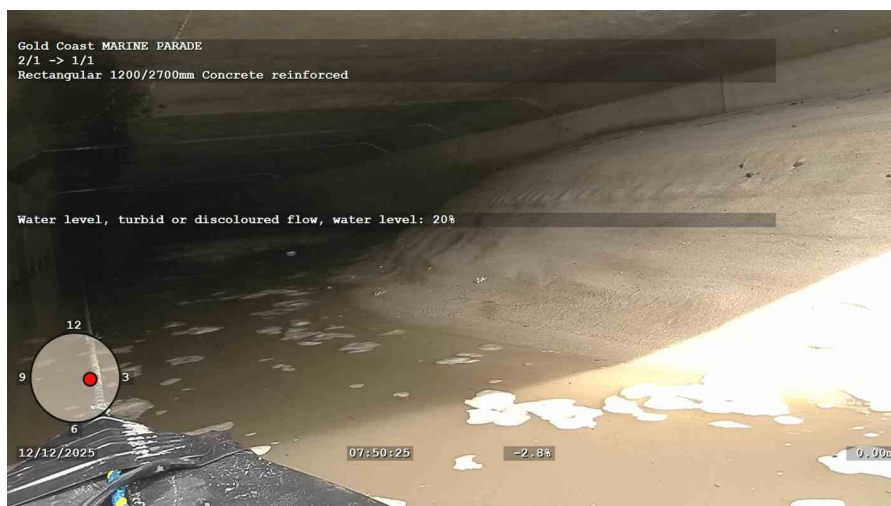
2, 00:00:39, 0.00  
 Water level, turbid or discoloured flow, water level: 20%

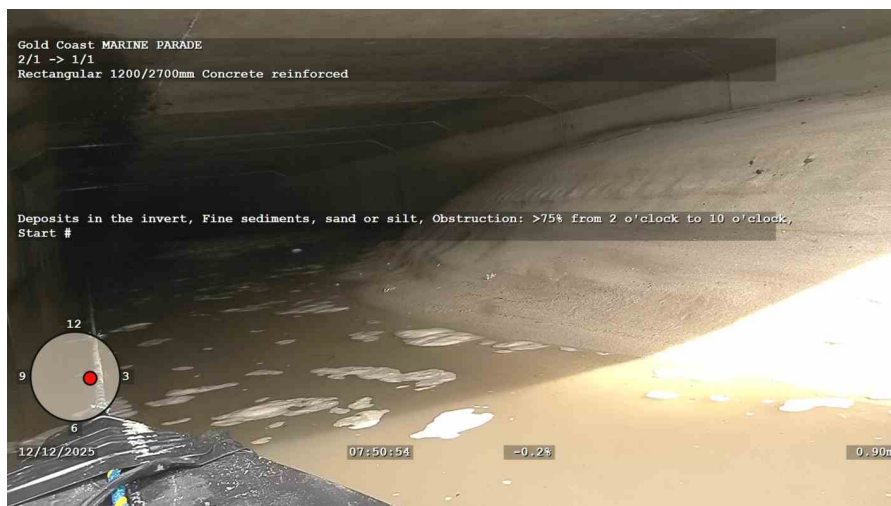
3, 00:00:53, 0.90

Deposits in the invert, Fine sediments, sand or silt, Obstruction: >75% from 2 o'clock to 10 o'clock, Start #

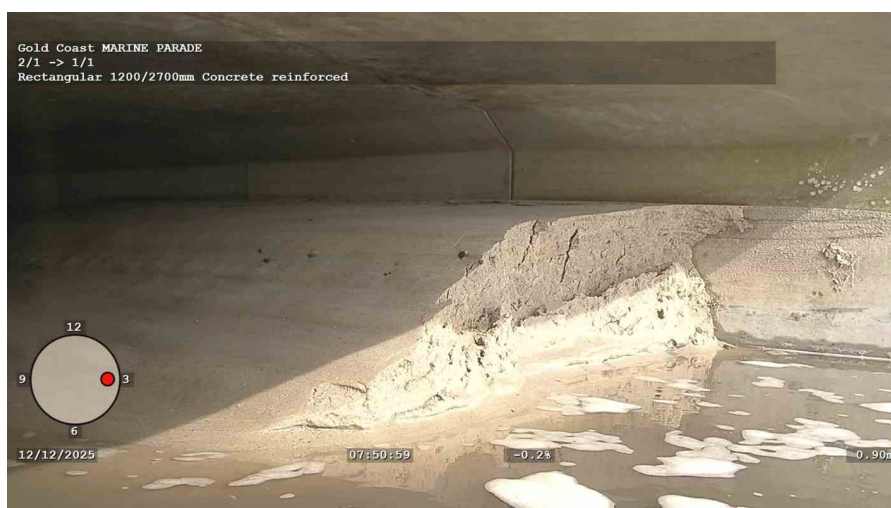
4, 00:00:53, 0.90

Deposits in the invert, Fine sediments, sand or silt, Obstruction: >75% from 2 o'clock to 10 o'clock, Start #

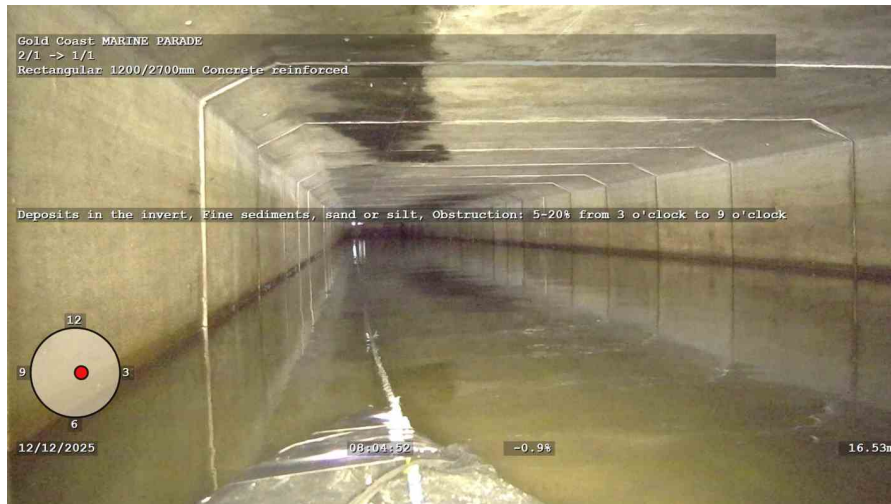
5, 00:08:26, 16.53

Deposits in the invert, Fine sediments, sand or silt, Obstruction: 5-20% from 3 o'clock to 9 o'clock

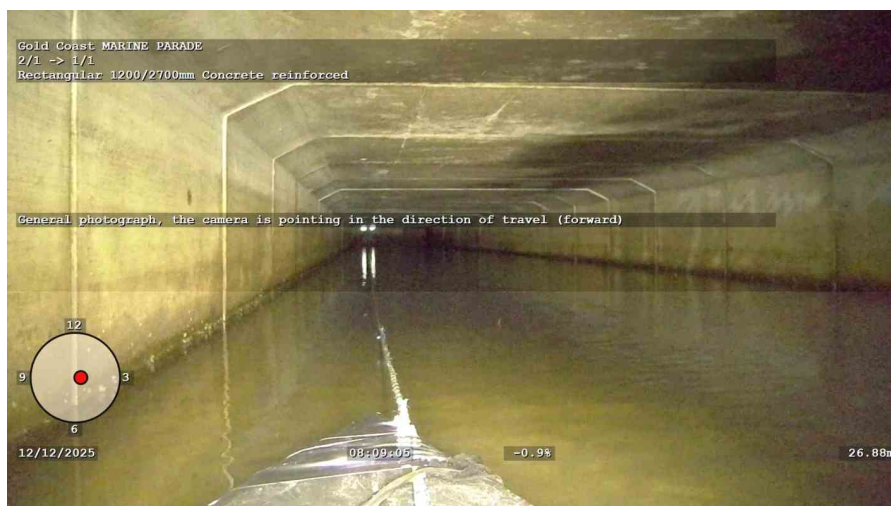
6, 00:12:33, 26.88

General photograph, the camera is pointing in the direction of travel (forward)

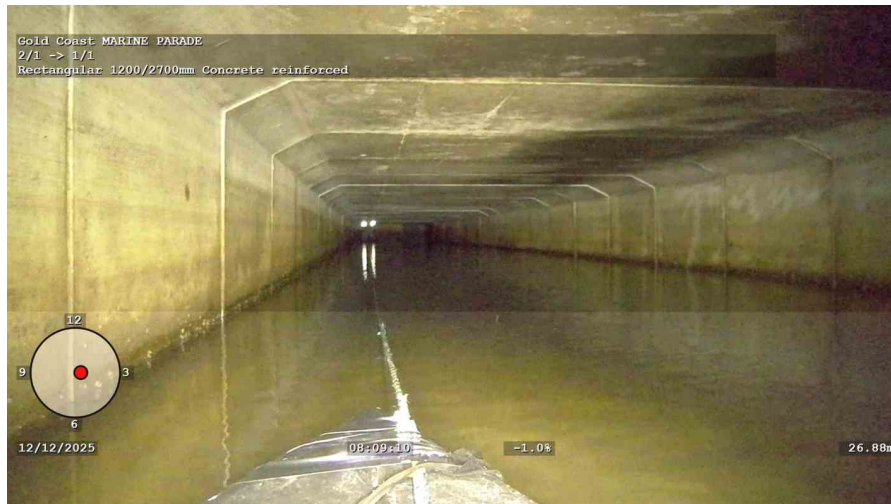
7, 00:12:33, 26.88  
 General photograph, the camera is pointing in the direction of travel (forward)

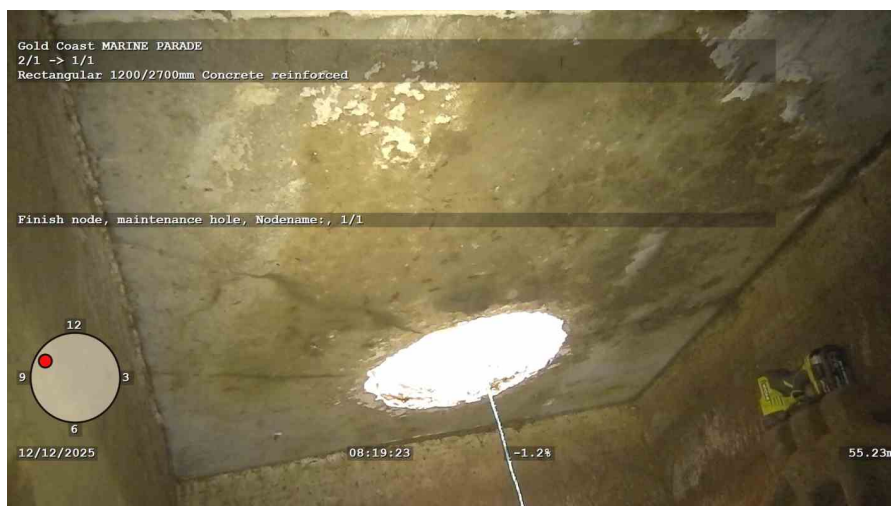
8, 00:22:44, 55.24  
 Finish node, maintenance hole, Nodename:, 1/1

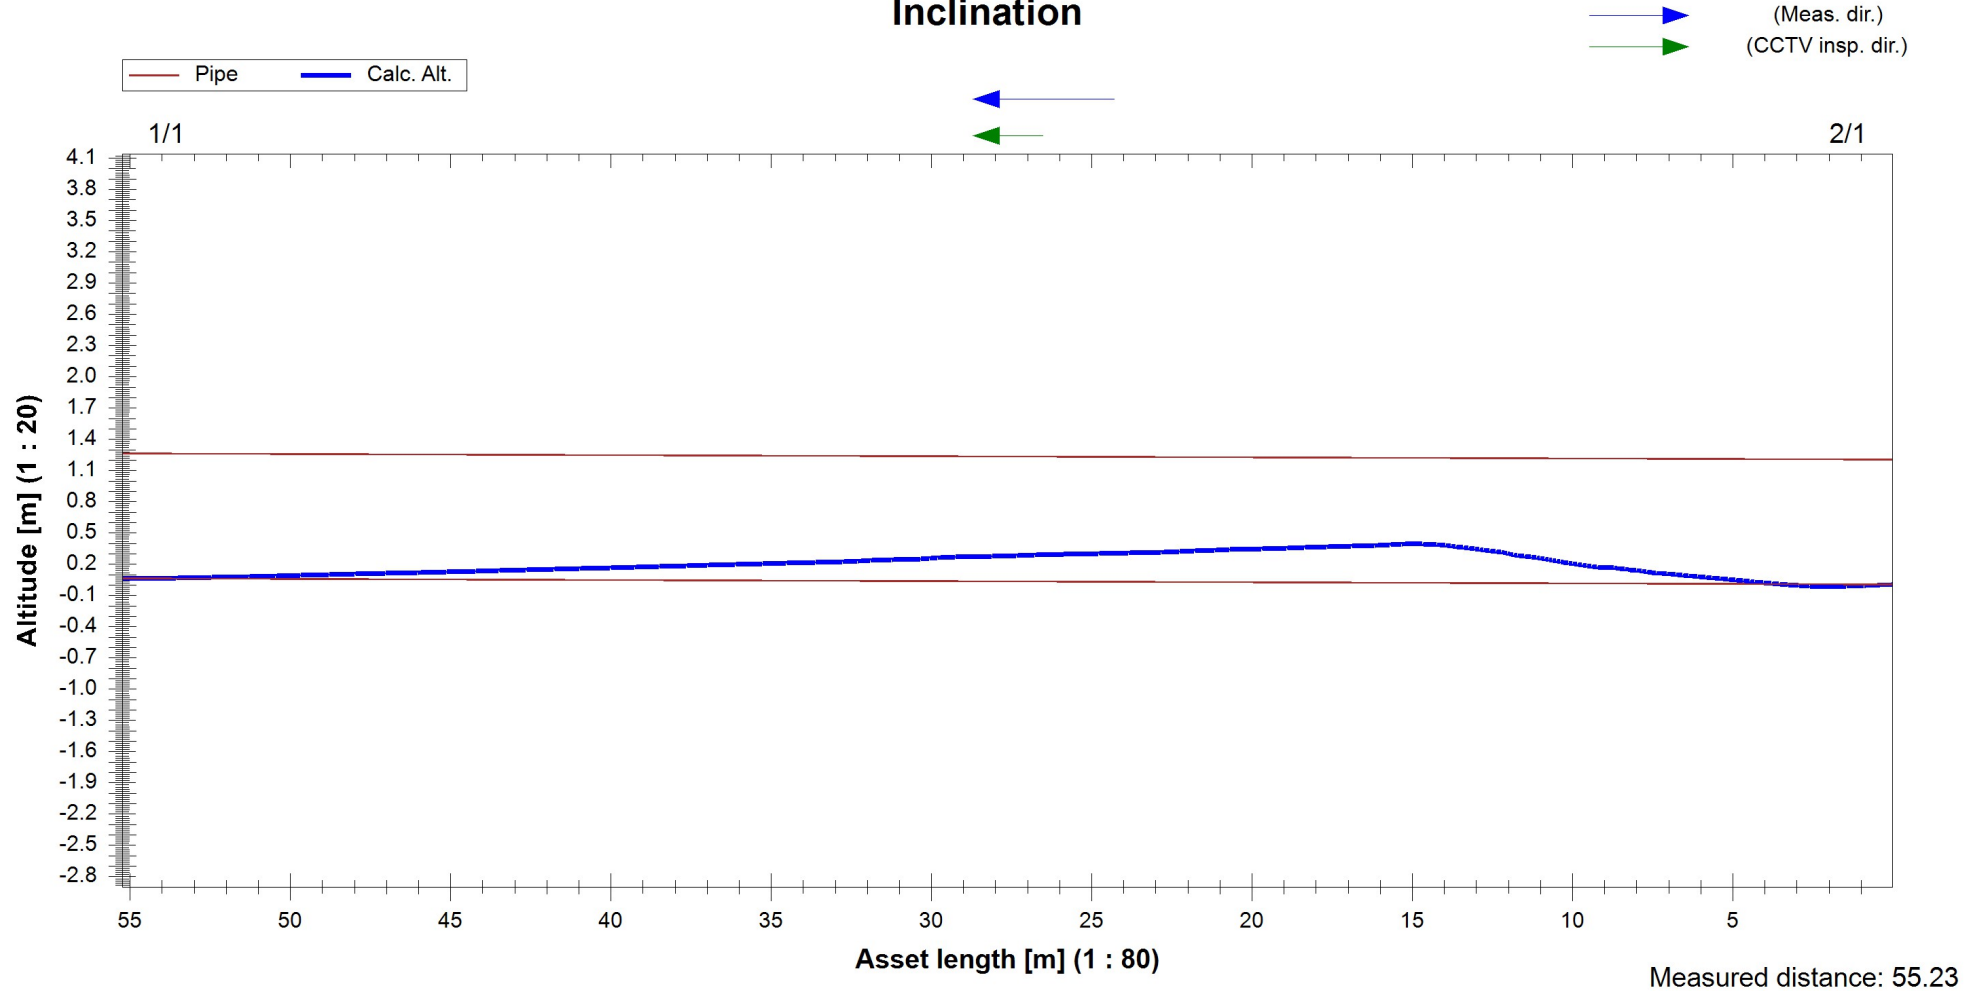
### Inclination

| <b>Shape</b><br>Rectangular | <b>Dia/Height</b><br>1,200 mm | <b>Width</b><br>2,700 mm | <b>US MH</b><br>1/1 | <b>DS MH</b><br>2/1 | <b>Start altitude</b><br>0.000 m | <b>End altitude</b><br>0.060 m | <b>Measured Inc</b><br>-0.109 % |
