Section Inspection - 28/02/2023 - E/10 - 03/03

Date of inspection 28/02/2023	Time of inspection 9:30 AM	Land Ownership	Pipe Asset ID E/10 - 03/03	Nr. 1
Project name	Contract No.	Coding Standard WSA 05-2008 2.2	Name of operator DTA operator	Job ID 01

Town	US MH	E/10	Unit Length	0.00 m
Address Road 45	Direction	Downstream	GIS length	0.00 m
Location Type Light road	DS MH	03/03	Inspected Length	21.55 m
Operation Gravity sewer	Use	Sewage	Year Laid

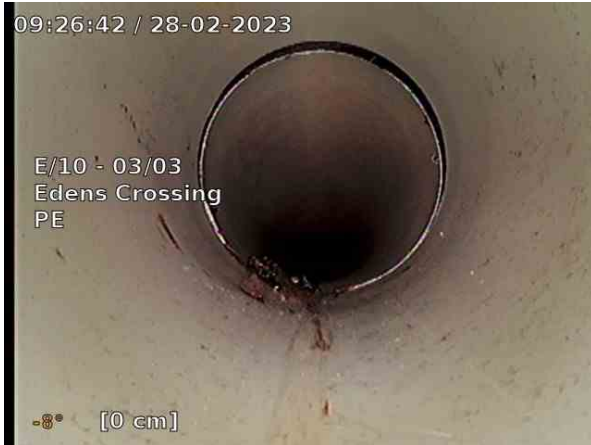
E_10 -
 03_03_7714770a-db32-4088-ac52-6f4dbb54cfa6_20230228_112533_593.jpg, 00:00:00, 0.00
 Start node, inspection opening, Nodename:, E/10

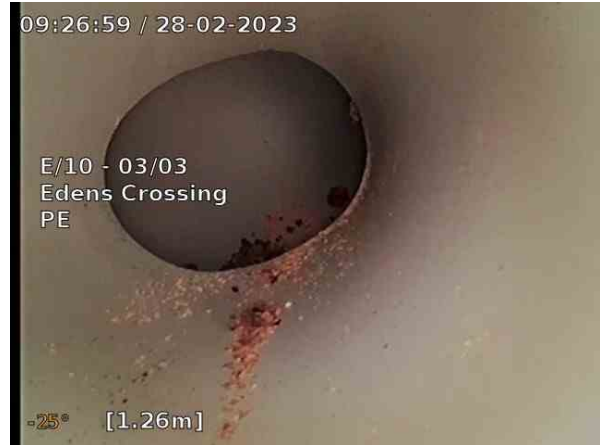
E_10 -
 03_03_184c275d-668a-4d9a-8bf3-c97ffd64c0a2_20230228_112625_881.jpg, 00:00:18, 1.26
 General comment / Propert connection into main (road crossing) sewer

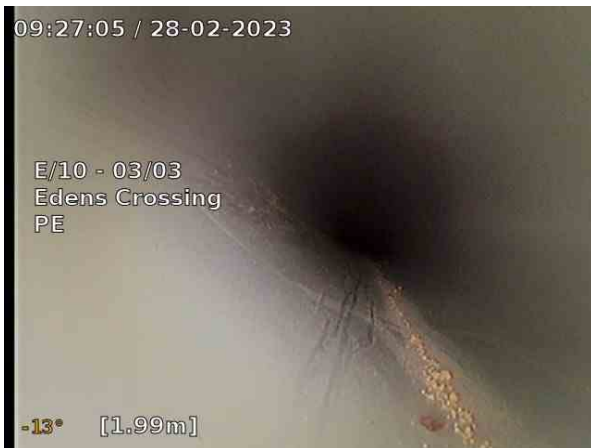
E_10 -
 03_03_5894c395-5e31-4293-bf9f-453be1b52057_20230228_112743_724.jpg, 00:00:24, 1.99
 General comment / Camera in sewer main 160 PE

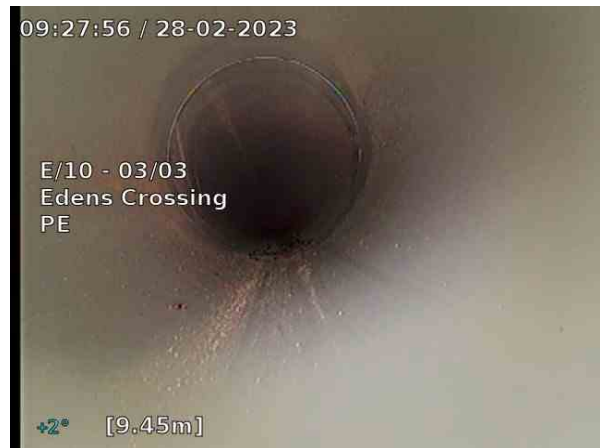
E_10 -
 03_03_c5f9586e-faaf-49fb-bd5a-ce93fd48b1e9_20230228_112816_222.jpg, 00:01:15, 9.45
 General photograph, the camera is pointing in the direction of travel (forward)

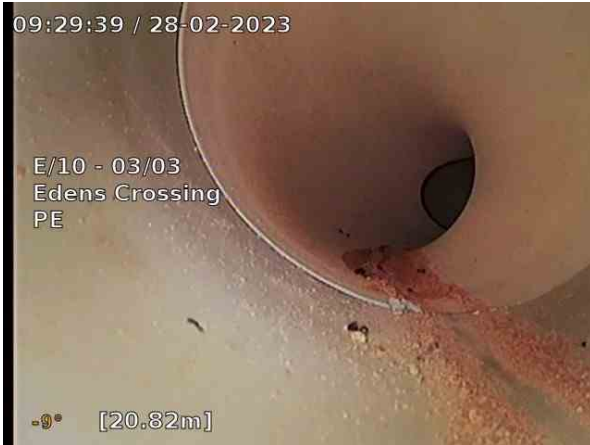
E_10 -
 03_03_4b9131c8-c9bf-452a-9f94-1cb7b09bc443_20230228_1
 12852_156.jpg, 00:02:57, 20.82
 General photograph, the camera is pointing in the direction of
 travel (forward)

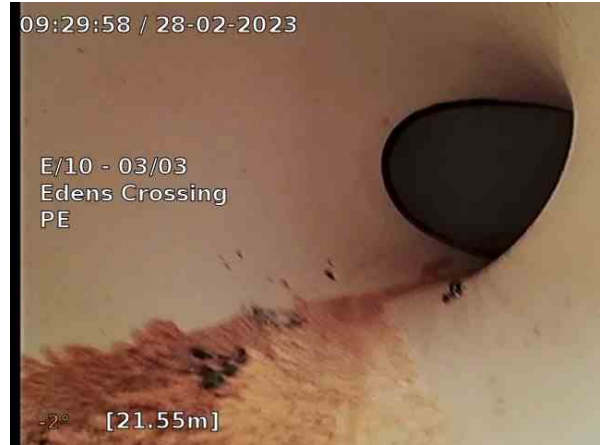
E_10 -
 03_03_98be17d0-0323-4b96-9369-f097f5a38149_20230228_
 112905_846.jpg, 00:02:57, 20.82
 General photograph, the camera is pointing in the direction of
 travel (forward)

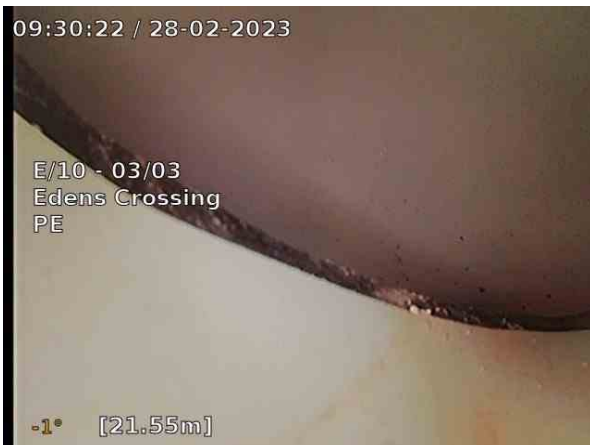
E_10 -
 03_03_d220e86e-f97e-4674-b04a-ddf97f95c25e_20230228_1
 12926_195.jpg, 00:03:41, 21.55
 Finish node, junction or connection with another conduit,
 Nodename:, 03/03
