## Section Inspection - 11/05/2026 - Unknown Chamber- C-HW256

| Project name | Contractor's Job Number | Coding Standard | Unknown Chamber- C-HW256 | 7 |

| Location Type | DS MH | C-HW256 | Inspected Length | 91.62 m |

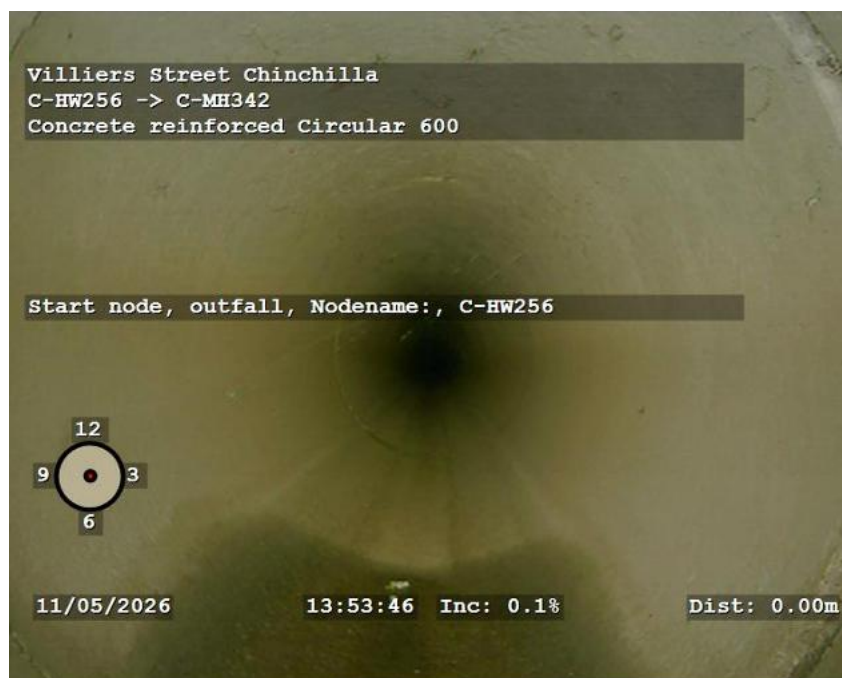
1288411052026 15347 PM.jpg, 00:00:00, 0.00  
Start node, outfall, Nodename:, C-HW256

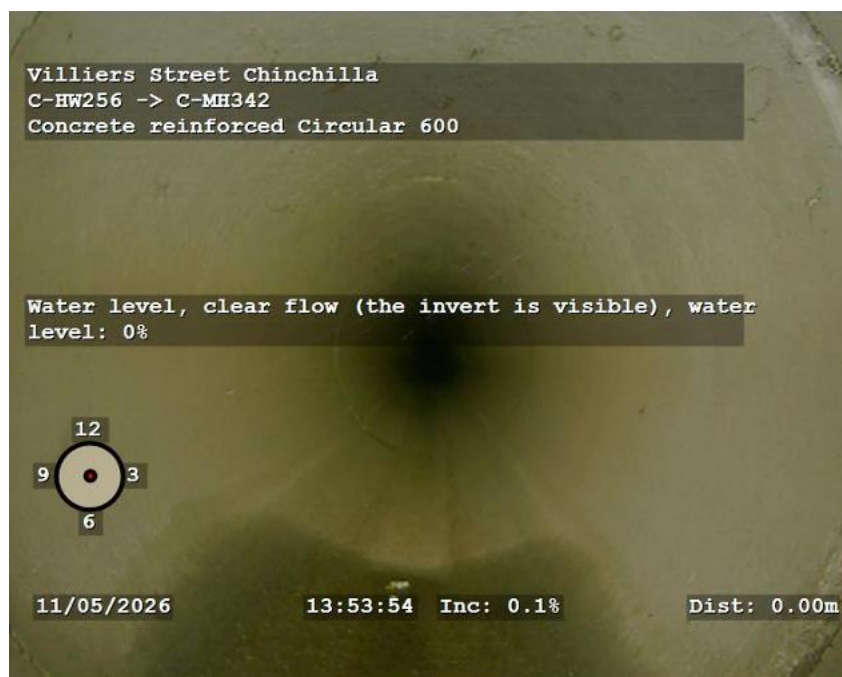
3417711052026 15355 PM.jpg, 00:00:16, 0.00  
Water level, clear flow (the invert is visible), water level: 0%

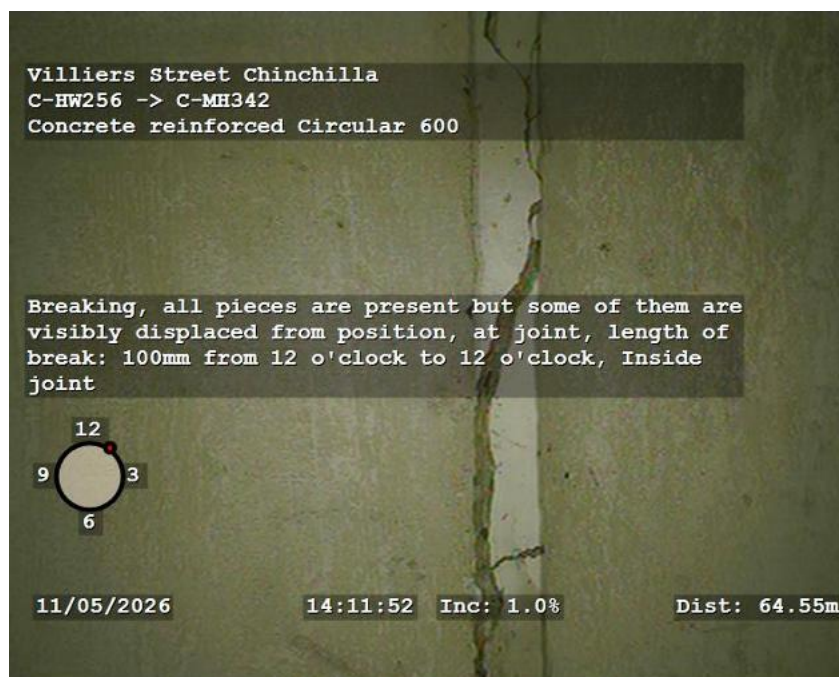
5271511052026 21153 PM.jpg, 00:15:19, 64.55

| 1:583 | m+ | Code | Observation Text | Grade |
|---|---|---|---|---|
| | 64.55 | BD | Breaking, all pieces are present but some of them are visibly displaced from position, at joint, length of break: 100mm from 12 o'clock to 12 o'clock / Inside | 4 |

Breaking, all pieces are present but some of them are visibly displaced from position, at joint, length of break: 100mm from 12 o'clock to 12 o'clock / Inside joint

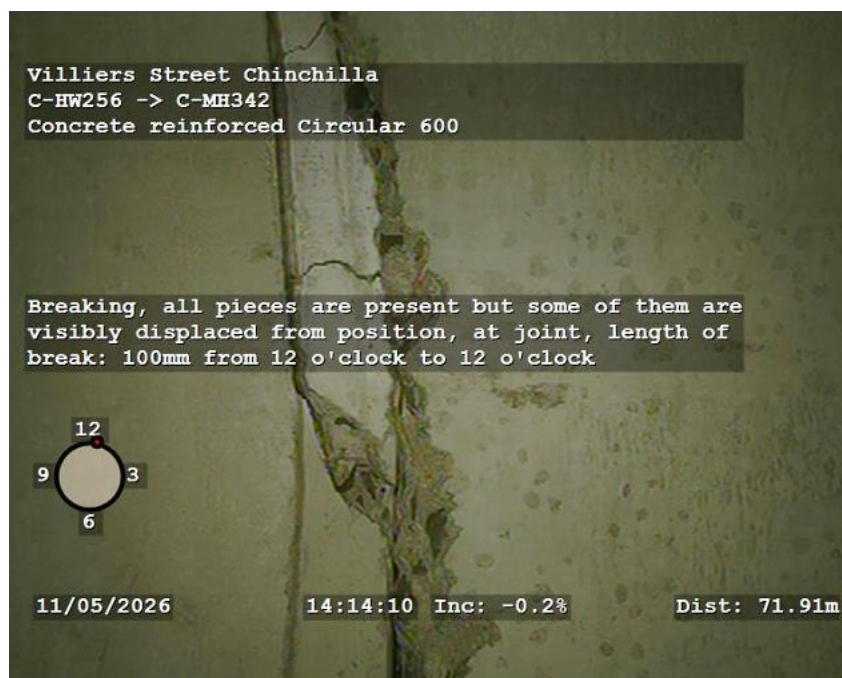
2136711052026 21411 PM.jpg, 00:17:07, 71.91

| 1:583 | m+ | Code | Observation Text | Grade | |
|---|---|---|---|---|---|
| | 71.91 | BD | Breaking, all pieces are present but some of them are visibly displaced from position, at joint, length of break: 100mm from 12 o'clock to 12 o'clock | 4 | |

Breaking, all pieces are present but some of them are visibly displaced from position, at joint, length of break: 100mm from 12 o'clock to 12 o'clock

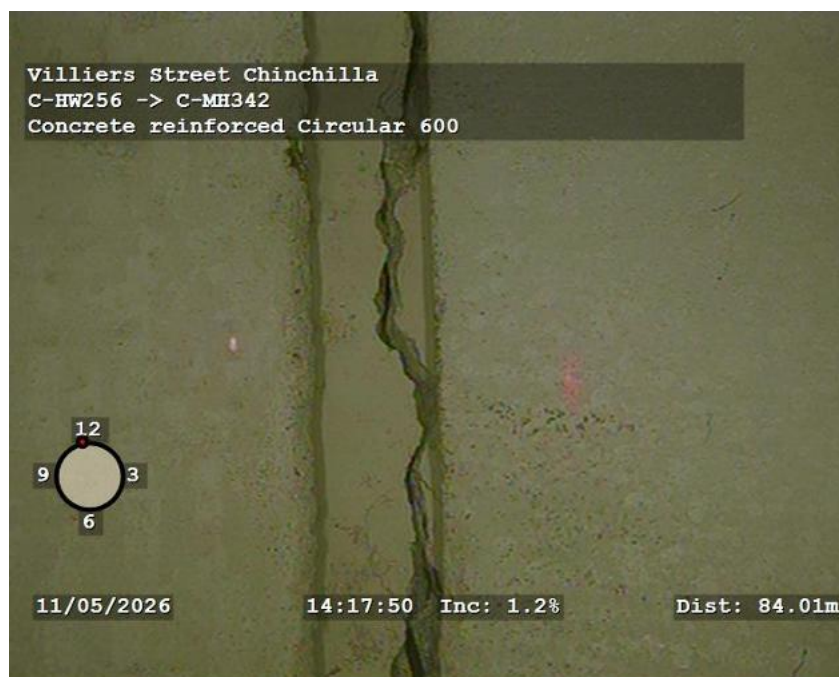
683011052026 21751 PM.jpg, 00:20:26, 84.01

| 1:583 | m+ | Code | Observation Text | Grade | |
|---|---|---|---|---|---|
| | 84.01 | FC | Circumferential fracture, at joint, width: 2.195mm from 12 o'clock to 12 o'clock | 2 | |

Circumferential fracture, at joint, width: 2.195mm from 12 o'clock to 12 o'clock

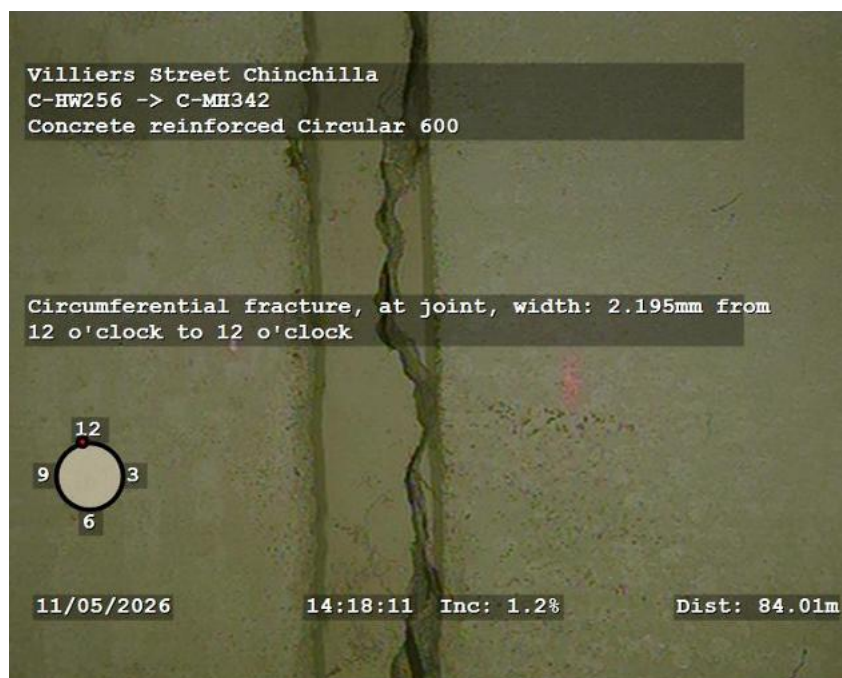
770411052026 21812 PM.jpg, 00:20:26, 84.01

Circumferential fracture, at joint, width: 2.195mm from 12 o'clock to 12 o'clock

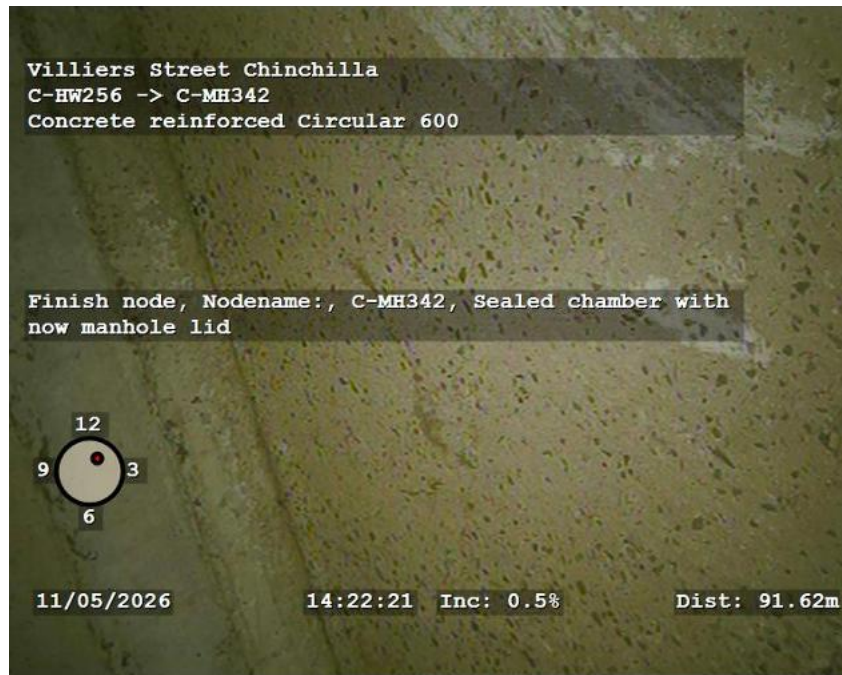
Finish node, Nodename:, Unknown Chamber / Sealed chamber with no manhole lid
