## Section Inspection - 27/04/2020 - SMH3113 - SMH3645

| Date of inspection<br><b>27/04/2020</b> | Time of inspection<br><b>8:15 AM</b> | Asset Owner<br><b>SDRC</b> | Pipe Asset ID<br><b>SMH3113 - SMH3645</b> | Nr.<br><b>2</b> |
| Project name<br><b>SDRC - Stanthorpe - Pre Survey ZONE 1</b> | Contract No. | Coding Standard<br><b>WSA 05-2008 2.2</b> | Name of operator<br><b>Steven Gall</b> | Job Number<br><b>00</b> |

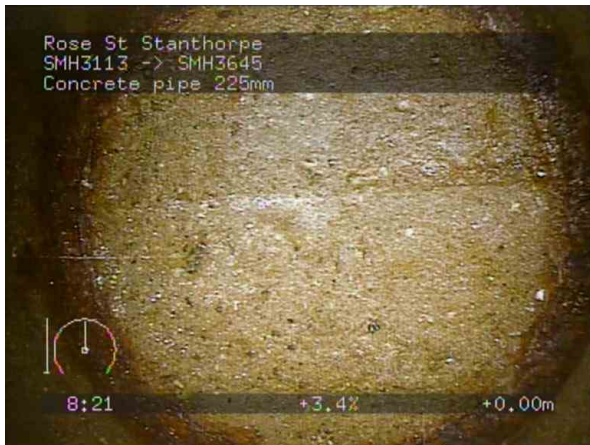
SMH3113 -  
SMH3645\_0733ade3-9d6a-46ff-ad89-590ab6010539\_202004  
27\_082230\_162.jpg, 00:00:00, 0.00  
Start node, maintenance hole, Nodename:, SMH3645

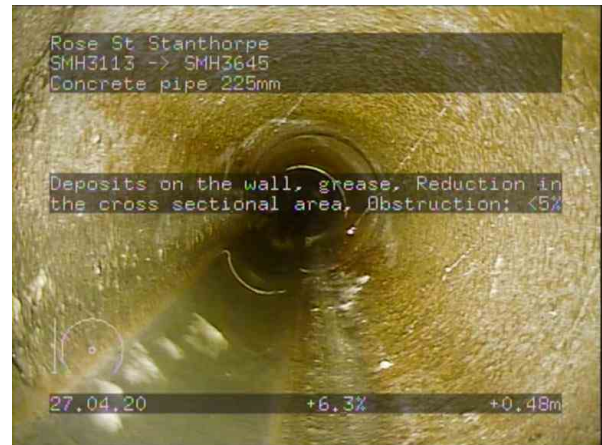
| 1:135 | [m] | Code | Observation Text | Grade |
|---|---|---|---|---|
| | 0.48 | S01 DEG | Deposits on the wall, grease, Reduction in the cross sectional area, Obstruction: <5% from 12 o'clock, Start # | |

SMH3113 -  
SMH3645\_b8763b76-02f3-454e-b5e5-1cc7ba81559b\_202004  
27\_082324\_726.jpg, 00:01:15, 0.48  
Deposits on the wall, grease, Reduction in the cross sectional  
area, Obstruction: <5% from 12 o'clock to 12 o'clock, Start #

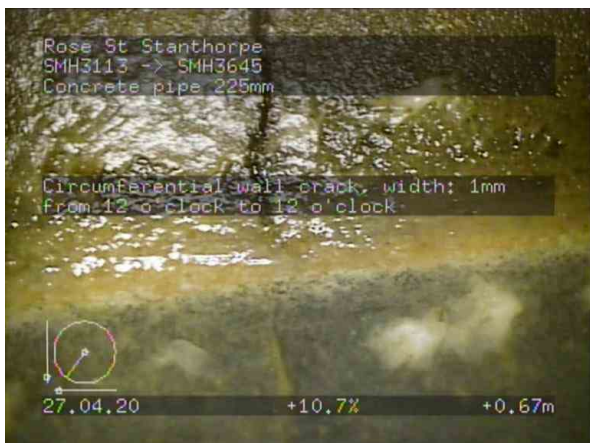
| 1:135 | [m] | Code | Observation Text | Grade |
|---|---|---|---|---|
| | 0.67 | CCW | Circumferential wall crack, width: 1mm from 12 o'clock to 12 o'clock | 1 |

SMH3113 -  
SMH3645\_5f7be426-3515-463c-ae9e-3a50f1e30f52\_2020042  
7\_082347\_098.jpg, 00:01:30, 0.67  
Circumferential wall crack, width: 1mm from 12 o'clock to 12  
o'clock

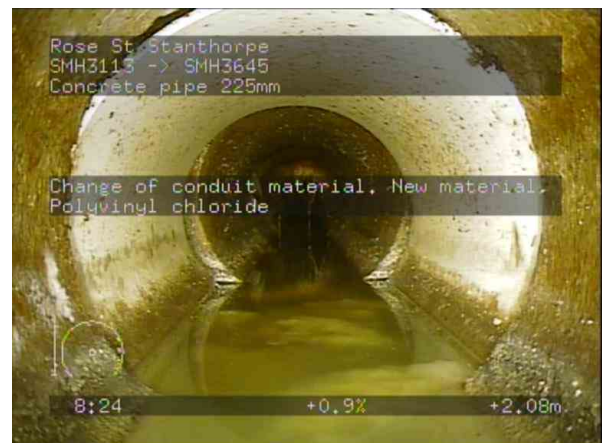
SMH3113 -  
SMH3645\_eb0aba98-0190-4a3f-87af-436d8ab76472\_202004  
27\_082459\_238.jpg, 00:02:32, 2.08  
Change of conduit material. New material, Polyvinyl chloride

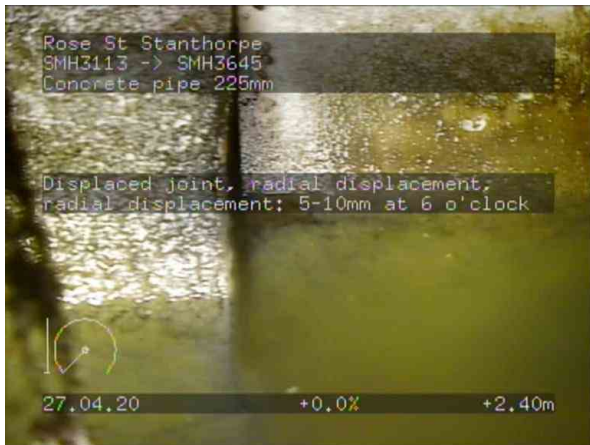
| 1:135 | [m] | Code | Observation Text | Grade |
|---|---|---|---|---|
| | 2.40 | JDR | Displaced joint, radial displacement, radial displacement: 5-10mm at 6 o'clock | 1 |

SMH3113 -  
SMH3645\_665492aa-3c9e-42dd-8f26-2fa9405c0485\_202004  
27\_082523\_289.jpg, 00:02:44, 2.40  
Displaced joint, radial displacement, radial displacement:  
5-10mm at 6 o'clock

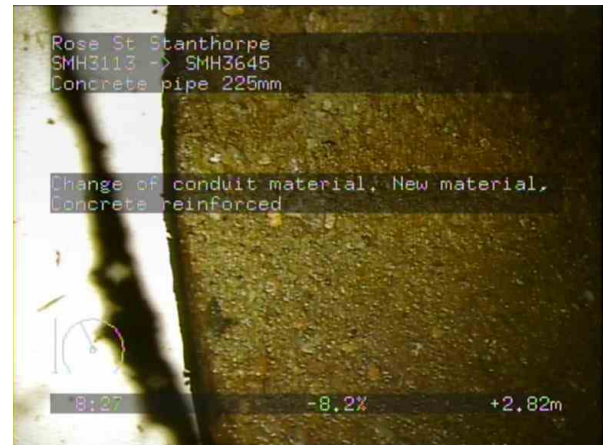
SMH3113 -  
SMH3645\_6fe91313-fef2-4907-ae39-d2c886c3b997\_2020042  
7\_082749\_003.jpg, 00:03:29, 2.82  
Change of conduit material. New material, Concrete reinforced

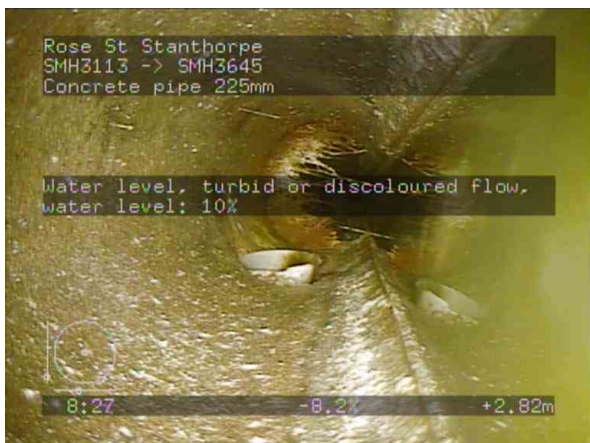
SMH3113 -  
SMH3645\_64d4bb73-3339-45be-b99a-69f05d666b40\_202004  
27\_082812\_080.jpg, 00:03:47, 2.82  
Water level, turbid or discoloured flow, water level: 10%

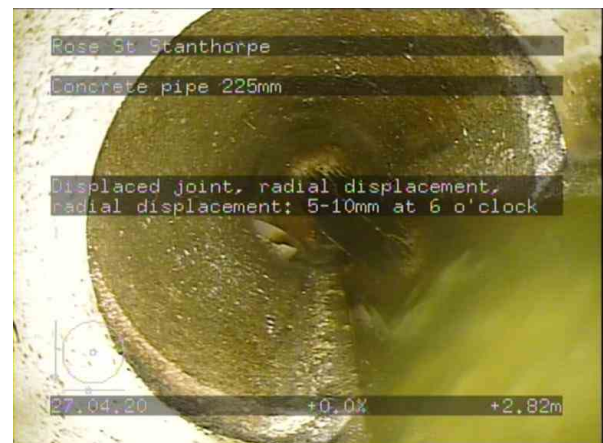
| 1:135 | [m] | Code | Observation Text | Grade |
|---|---|---|---|---|
| | 2.82 | JDR | Displaced joint, radial displacement, radial displacement: 5-10mm at 6 o'clock | 1 |

SMH3113 -  
SMH3645\_a0c2278c-0dc2-4ceb-a285-60acb5a37b37\_202004  
27\_082831\_449.jpg, 00:03:58, 2.82  
Displaced joint, radial displacement, radial displacement:  
5-10mm at 6 o'clock

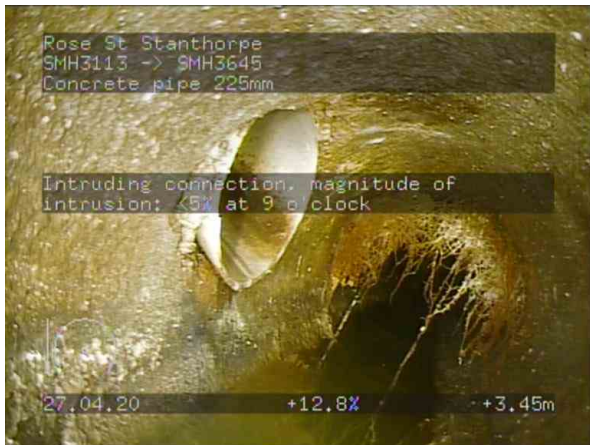
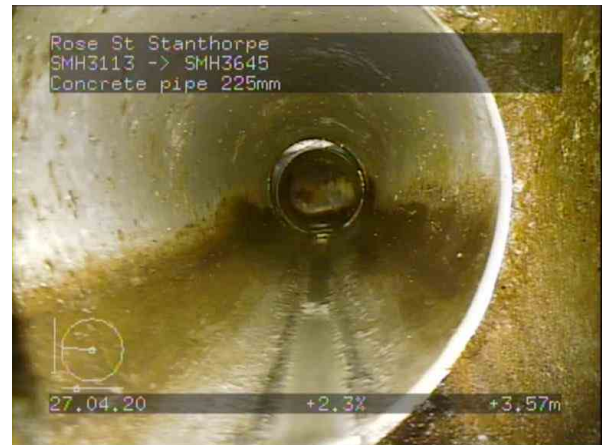
| 1:135 | [m] | Code | Observation Text | Grade |
|---|---|---|---|---|
| | 3.45 | CI | Intruding connection, magnitude of intrusion: <5% at 9 o'clock / 100mm | 2 |

SMH3113 -  
SMH3645\_8e5c4093-05a4-4d6e-84a7-065e190622e5\_20200427\_082926\_472.jpg, 00:04:27, 3.45  
Intruding connection, magnitude of intrusion: <5% at 9 o'clock

SMH3113 -  
SMH3645\_6a1202b8-fdfb-4994-adcd-5b474aa18ad6\_20200427\_082939\_776.jpg, 00:04:27, 3.45  
Intruding connection, magnitude of intrusion: <5% at 9 o'clock

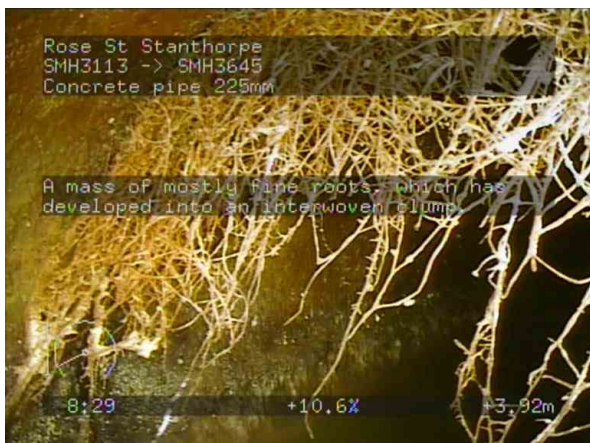
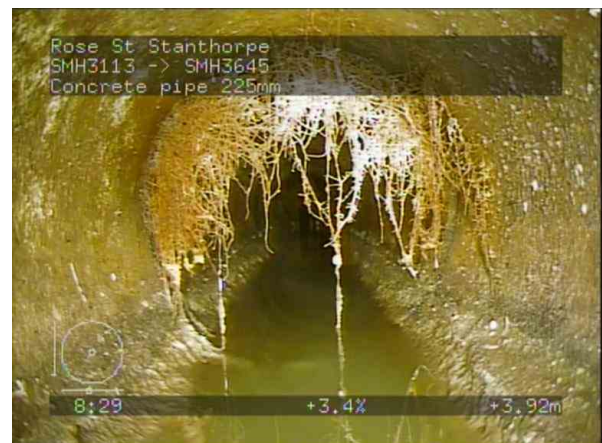
| 1:135 | [m] | Code | Observation Text | Grade |
|---|---|---|---|---|
| | 3.92 | RM | A mass of mostly fine roots, which has developed into an interwoven clump, Obstruction: 5-20% from 8 o'clock to 4 o'clock | 3 |

SMH3113 -  
SMH3645\_b44c6d7d-2b95-45ce-ba5c-b1e081f2c3c1\_20200427\_083004\_935.jpg, 00:04:57, 3.92  
A mass of mostly fine roots, which has developed into an interwoven clump, Obstruction: 5-20% from 8 o'clock to 4 o'clock

SMH3113 -  
SMH3645\_2c652f55-5860-43fa-a582-48ae9676d206\_20200427\_083024\_702.jpg, 00:04:57, 3.92  
A mass of mostly fine roots, which has developed into an interwoven clump, Obstruction: 5-20% from 8 o'clock to 4 o'clock

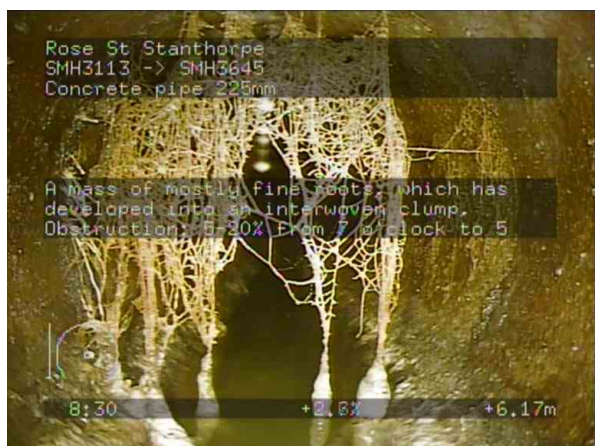
| 1:135 | [m] | Code | Observation Text | Grade |
|---|---|---|---|---|
| | 6.17 | RM | A mass of mostly fine roots, which has developed into an interwoven clump, Obstruction: 5-20% from 7 o'clock to 5 o'clock | 3 |

SMH3113 - SMH3645\_a09c4ef3-edee-4f3a-b582-7686910014e3\_20200427\_083117\_125.jpg, 00:05:59, 6.17  
A mass of mostly fine roots, which has developed into an interwoven clump, Obstruction: 5-20% from 7 o'clock to 5 o'clock

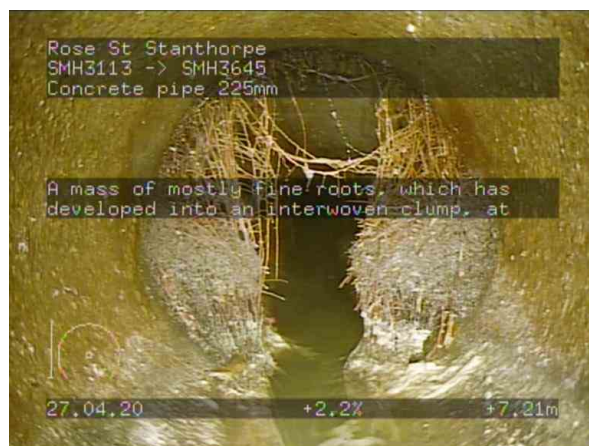
| 1:135 | [m] | Code | Observation Text | Grade |
|---|---|---|---|---|
| | 7.21 | RM | A mass of mostly fine roots, which has developed into an interwoven clump, at joint, Obstruction: 21-50% from 12 o'clock to 12 o'clock | 4 |

SMH3113 - SMH3645\_820c074b-1e0f-47aa-8af1-7b3a16a7871d\_20200427\_083201\_671.jpg, 00:06:30, 7.21  
A mass of mostly fine roots, which has developed into an interwoven clump, at joint, Obstruction: 21-50% from 12 o'clock to 12 o'clock

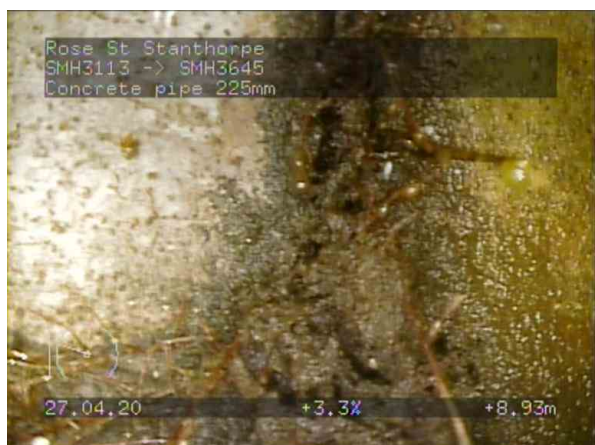
| 1:135 | [m] | Code | Observation Text | Grade |
|---|---|---|---|---|
| | 8.93 | RF | Fine roots--a relatively small number of flexible minor roots, Obstruction: <5% from 12 o'clock to 12 o'clock | 1 |

SMH3113 - SMH3645\_ac99604e-5eb2-4022-bd8a-2951b35ec24c\_20200427\_083251\_180.jpg, 00:07:07, 8.93  
Fine roots--a relatively small number of flexible minor roots, Obstruction: <5% from 12 o'clock to 12 o'clock

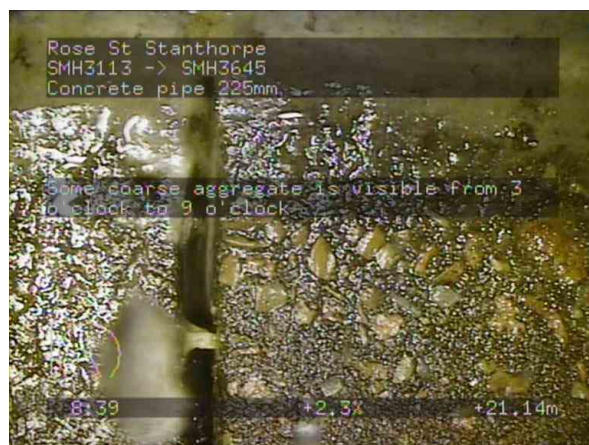
SMH3113 - SMH3645\_8e26d9a6-f200-4a67-ab1a-63c0deb0f079\_20200427\_084013\_661.jpg, 00:12:39, 21.14  
Some coarse aggregate is visible from 3 o'clock to 9 o'clock

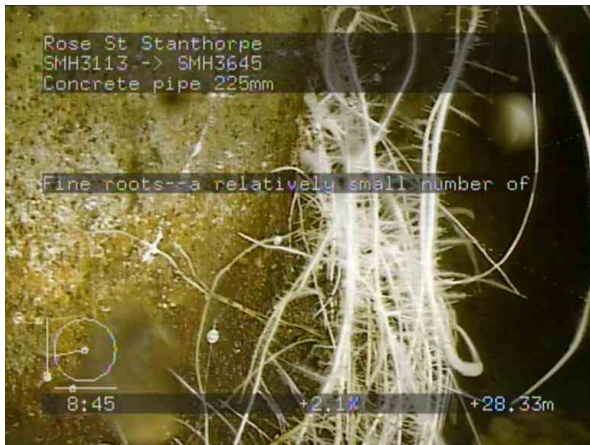
SMH3113 -  
SMH3645\_8aa7db36-cc52-4599-a904-ffbc53c0579c\_20200427\_084538\_119.jpg, 00:16:29, 28.33  
Fine roots--a relatively small number of flexible minor roots,  
Obstruction: <5% from 7 o'clock to 12 o'clock

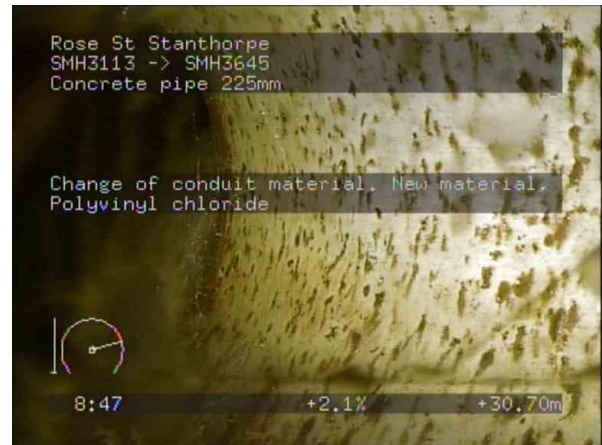
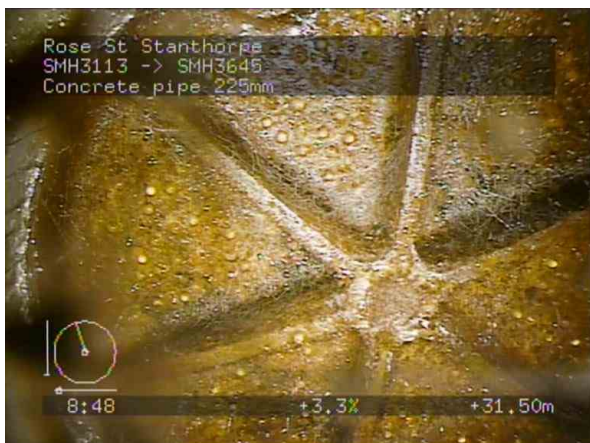
SMH3113 -  
SMH3645\_55560e68-babf-4255-b72c-89af9cc7b23d\_20200427\_084823\_820.jpg, 00:18:59, 30.70  
Change of conduit material. New material, Polyvinyl chloride

SMH3113 -  
SMH3645\_17960a96-4dca-445f-ac1e-b8e5b45668d1\_20200427\_084845\_673.jpg, 00:18:59, 30.70  
Change of conduit material. New material, Polyvinyl chloride
