## Section Inspection - 11/05/2026 - Unknown Chamber- C-HW256

| Project name | Contractor's Job Number | Coding Standard | Unknown Chamber- C-HW256 | 7 |

| Location Type | DS MH | C-HW256 | Inspected Length | 91.62 m |

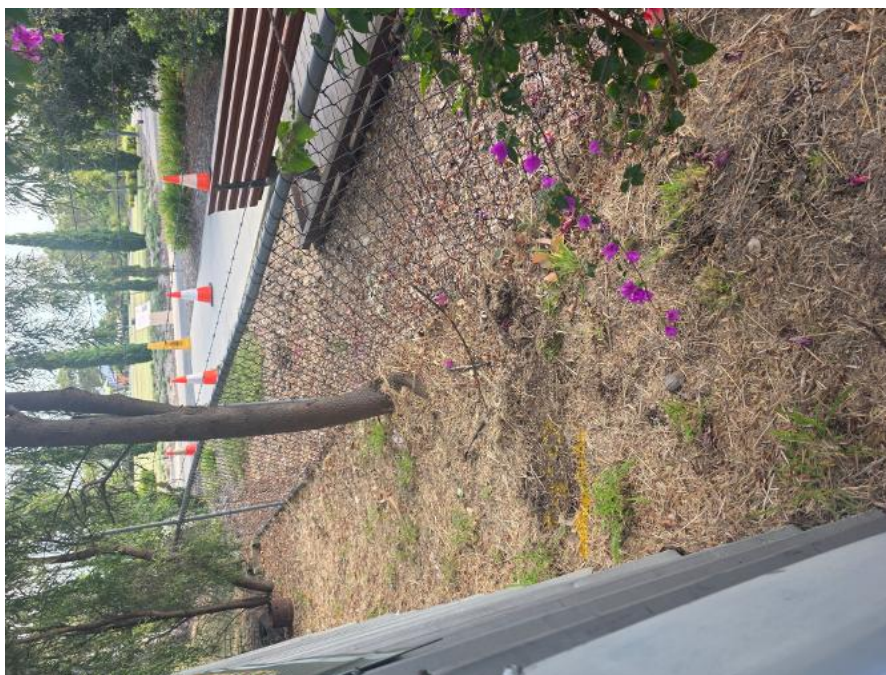
365412052026 75923 AM.jpg, 00:01:20, 3.11

General photograph, the camera is pointing in the direction of travel (forward) and horizontally from 12 o'clock to 12 o'clock / Location mark

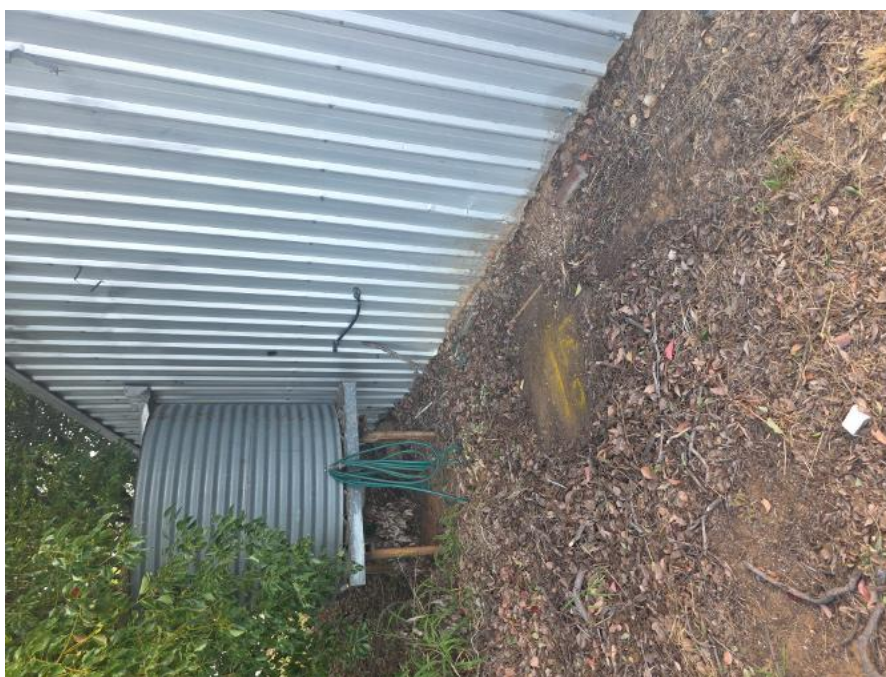
2750312052026 75938 AM.jpg, 00:03:51, 13.95

General photograph, the camera is pointing in the direction of travel (forward) and horizontally from 12 o'clock to 12 o'clock / Location photo

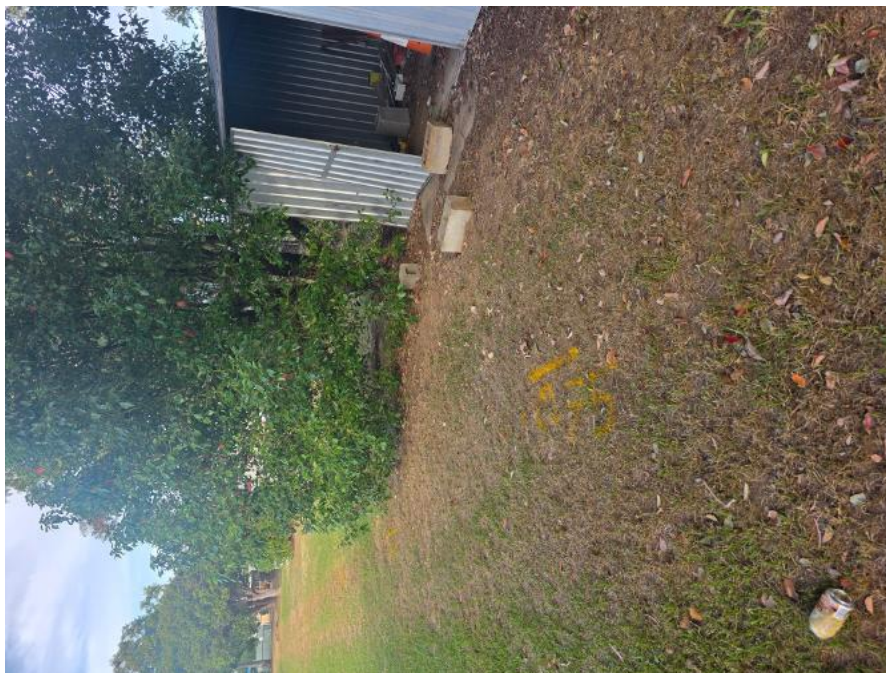
306412052026 75948 AM.jpg, 00:05:21, 20.23

General photograph, the camera is pointing in the direction of travel (forward) and horizontally from 12 o'clock to 12 o'clock / Location mark

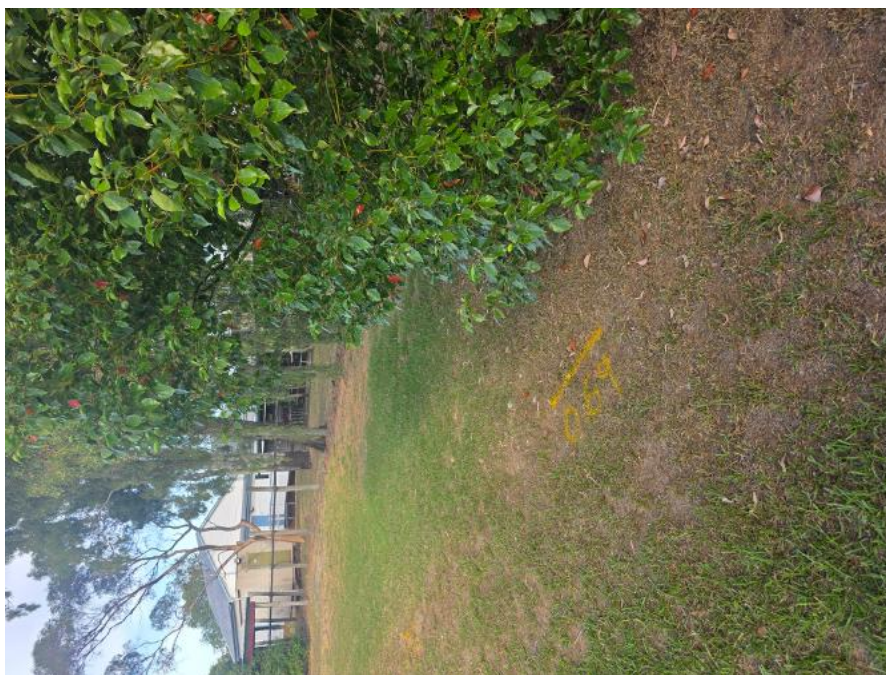
795312052026 75956 AM.jpg, 00:06:46, 25.21

General photograph, the camera is pointing in the direction of travel (forward) and horizontally from 12 o'clock to 12 o'clock / Location mark

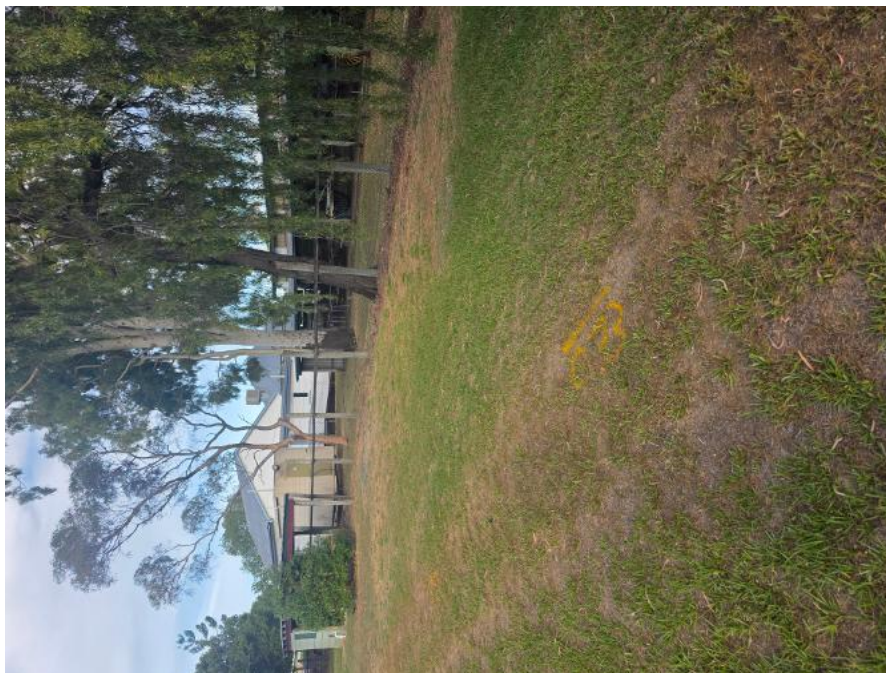
5784412052026 80002 AM.jpg, 00:07:47, 30.04

General photograph, the camera is pointing in the direction of travel (forward) and horizontally from 12 o'clock to 12 o'clock / Location mark

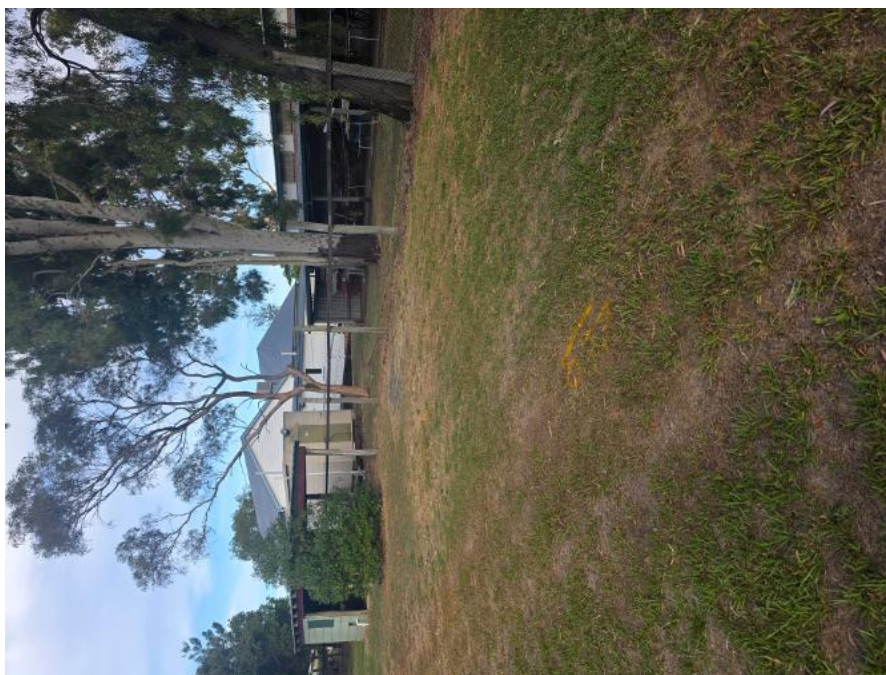
5920112052026 80008 AM.jpg, 00:08:49, 35.15

General photograph, the camera is pointing in the direction of travel (forward) and horizontally from 12 o'clock to 12 o'clock / Location mark

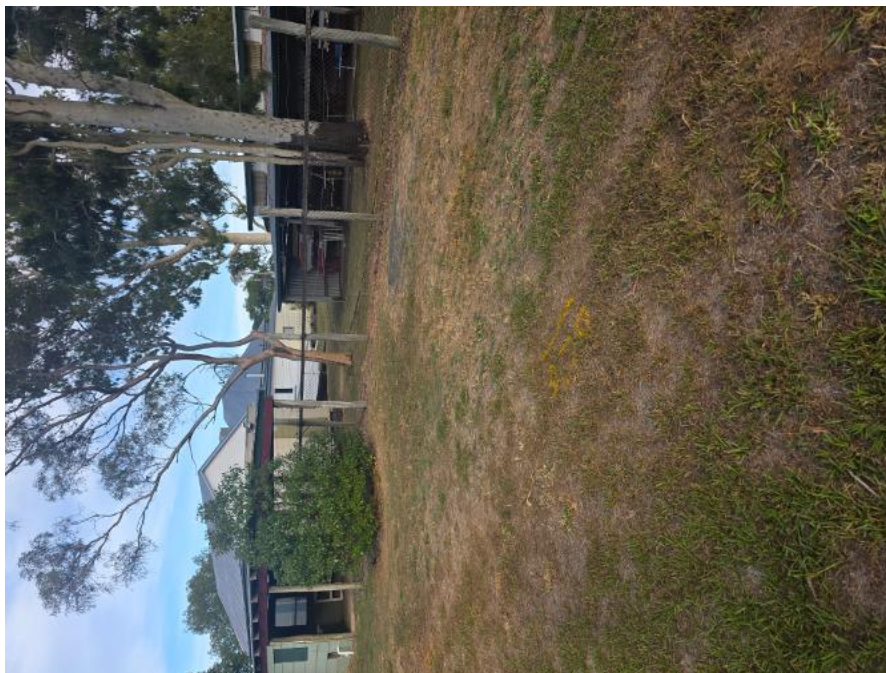
4394812052026 80015 AM.jpg, 00:09:52, 39.91

General photograph, the camera is pointing in the direction of travel (forward) and horizontally from 12 o'clock to 12 o'clock / Location mark

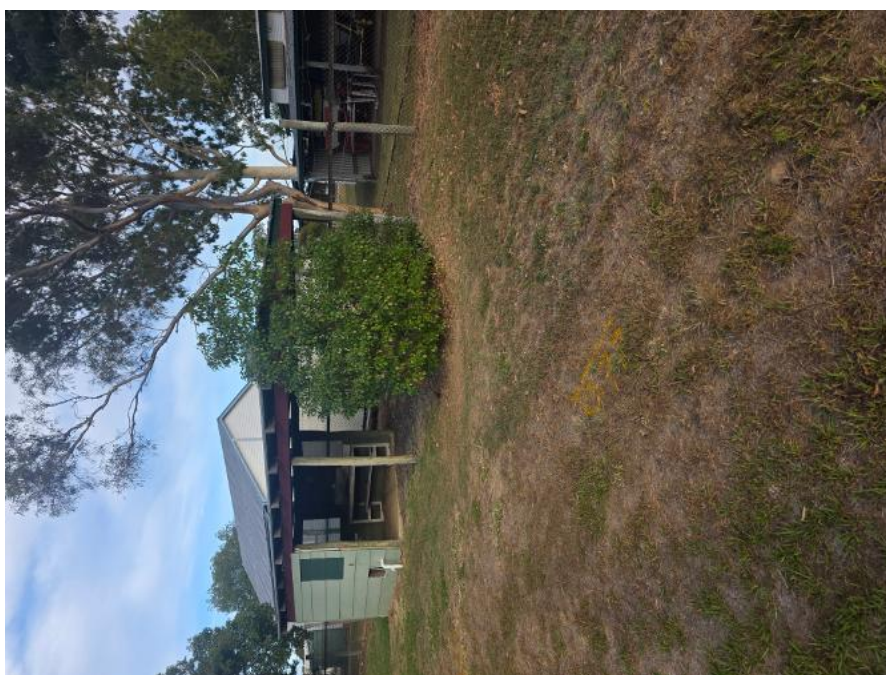
999312052026 80021 AM.jpg, 00:10:53, 44.87

General photograph, the camera is pointing in the direction of travel (forward) and horizontally from 12 o'clock to 12 o'clock

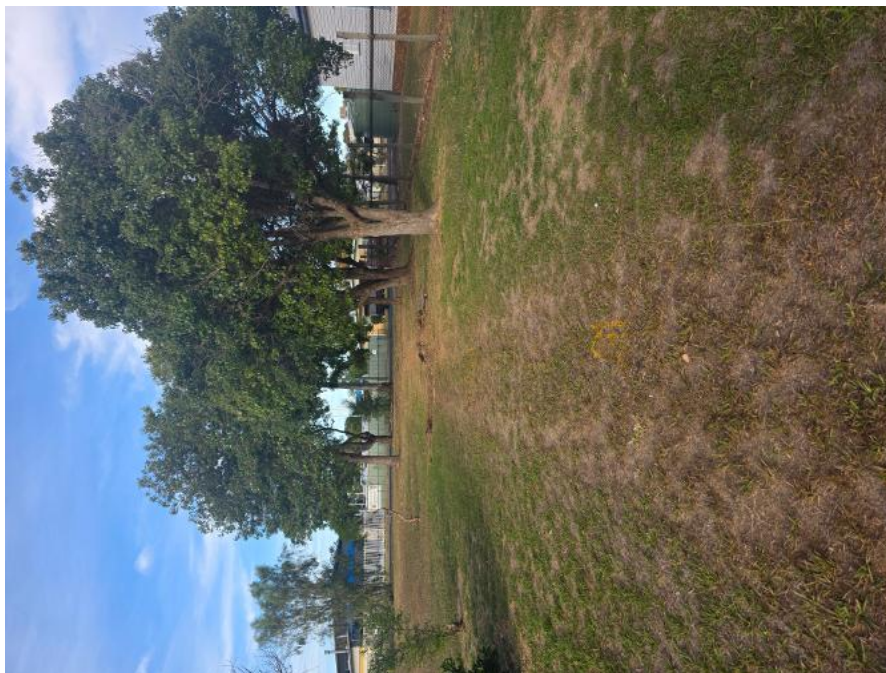
3811612052026 80033 AM.jpg, 00:11:54, 49.83

General photograph, the camera is pointing in the direction of travel (forward) and horizontally from 12 o'clock to 12 o'clock / Location mark

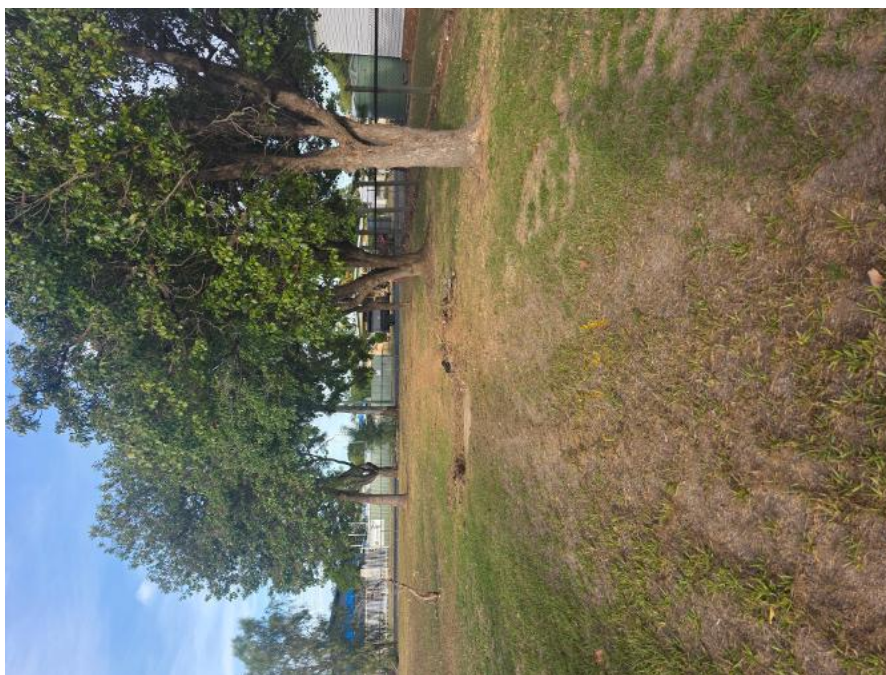
3869912052026 80039 AM.jpg, 00:13:10, 55.83

General photograph, the camera is pointing in the direction of travel (forward) and horizontally from 12 o'clock to 12 o'clock / Location mark

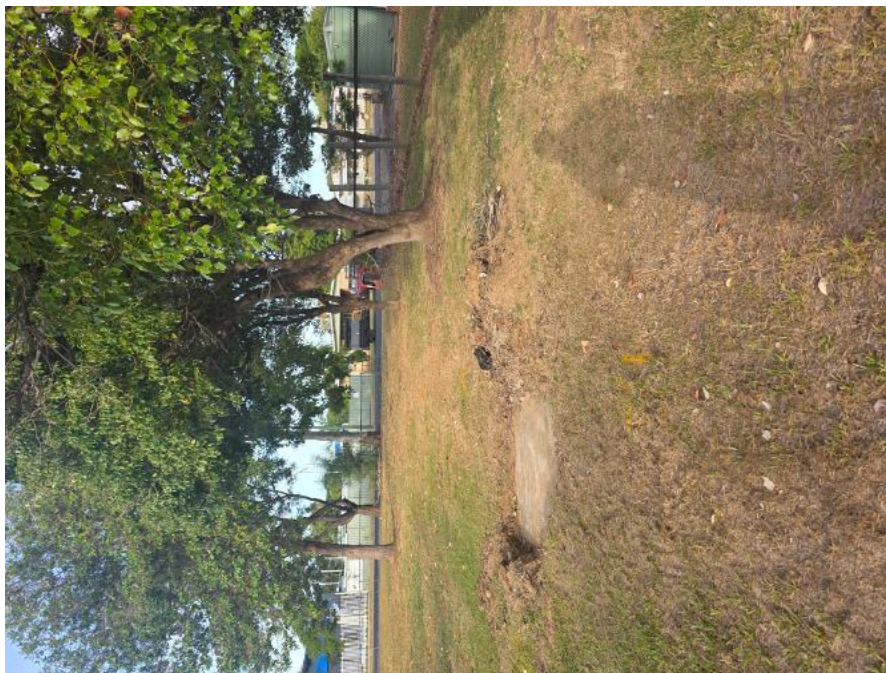
4610012052026 80045 AM.jpg, 00:14:33, 60.82

General photograph, the camera is pointing in the direction of travel (forward) and horizontally from 12 o'clock to 12 o'clock / Location mark

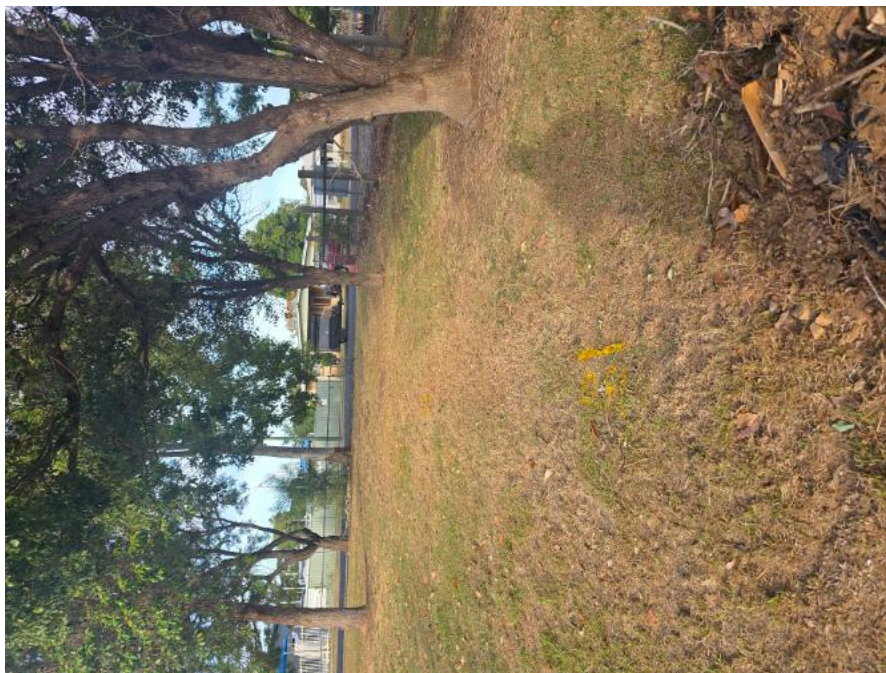
6434512052026 80052 AM.jpg, 00:15:39, 64.55

General photograph, the camera is pointing in the direction of travel (forward) and horizontally from 12 o'clock to 12 o'clock / Location mark

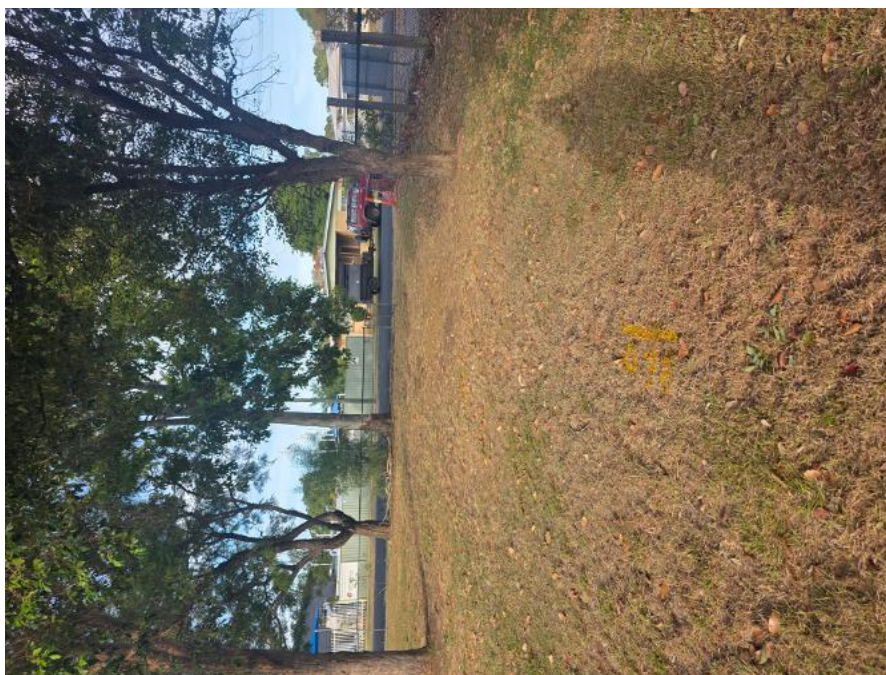
2624512052026 80058 AM.jpg, 00:16:41, 69.41

General photograph, the camera is pointing in the direction of travel (forward) and horizontally from 12 o'clock to 12 o'clock / Location mark

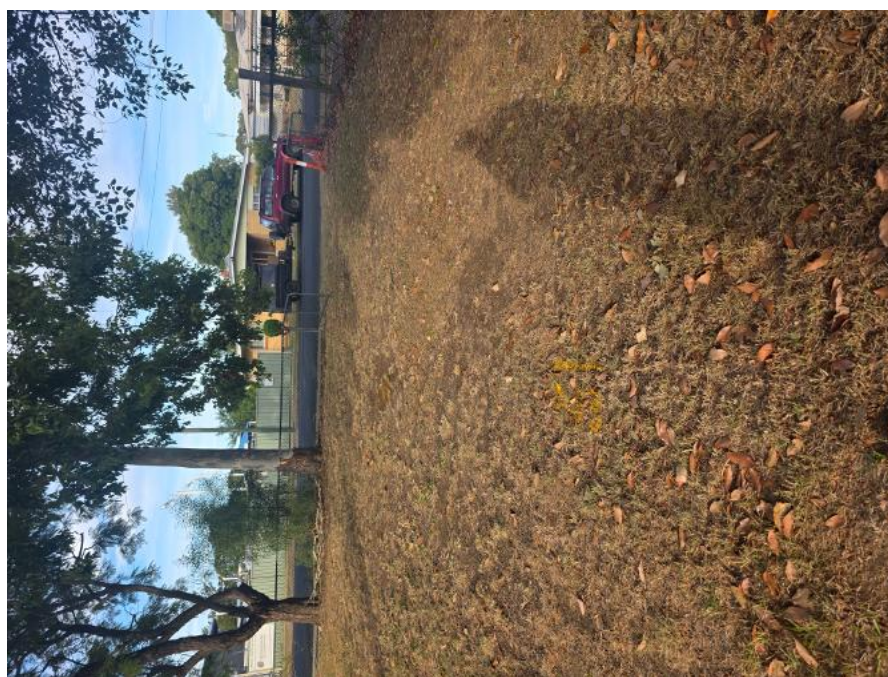
269112052026 80104 AM.jpg, 00:17:51, 74.29

General photograph, the camera is pointing in the direction of travel (forward) and horizontally from 12 o'clock to 1 o'clock / Location mark

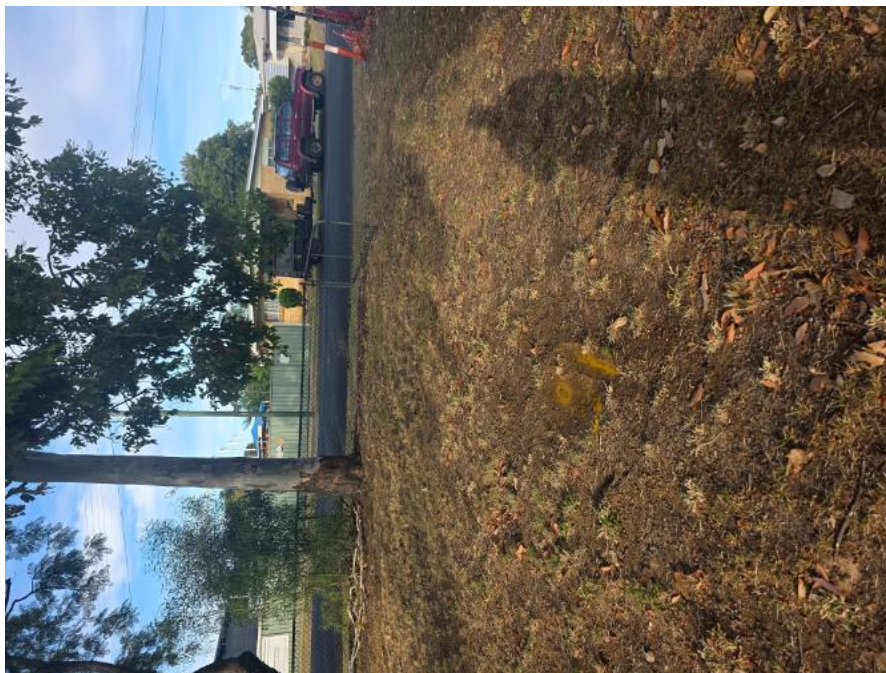
3112912052026 80110 AM.jpg, 00:18:52, 79.17

General photograph, the camera is pointing in the direction of travel (forward) and horizontally from 12 o'clock to 12 o'clock

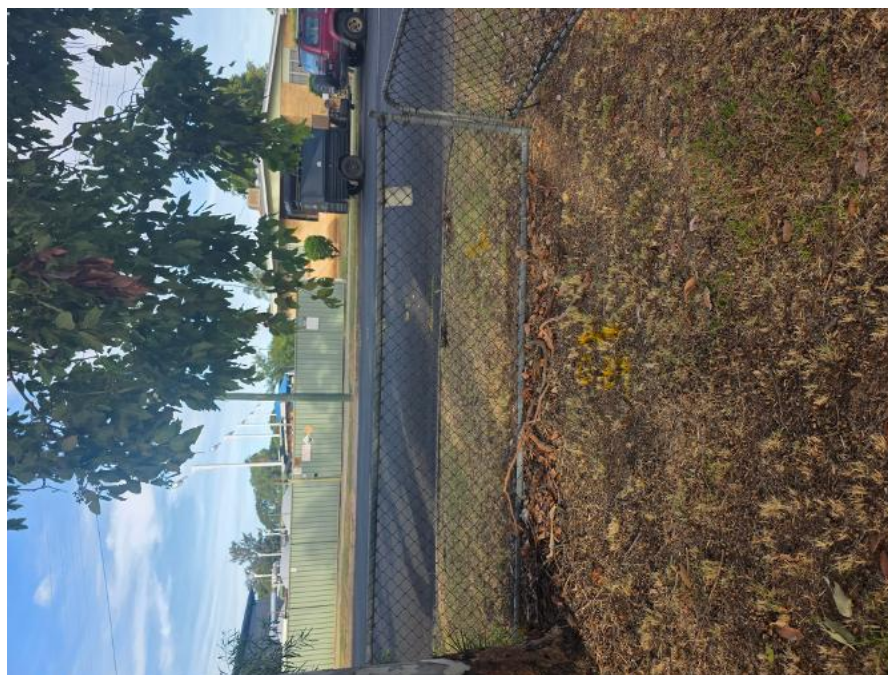
3121512052026 80118 AM.jpg, 00:20:44, 84.01

General photograph, the camera is pointing in the direction of travel (forward) and horizontally from 12 o'clock to 12 o'clock / Location mark
