## Section Inspection - 27/04/2020 - SMH3113 - SMH3645

| Date of inspection<br><b>27/04/2020</b> | Time of inspection<br><b>8:15 AM</b> | Asset Owner<br><b>SDRC</b> | Pipe Asset ID<br><b>SMH3113 - SMH3645</b> | Nr.<br><b>2</b> |
| Project name<br><b>SDRC - Stanthorpe - Pre Survey ZONE 1</b> | Contract No. | Coding Standard<br><b>WSA 05-2008 2.2</b> | Name of operator<br><b>Steven Gall</b> | Job Number<br><b>00</b> |

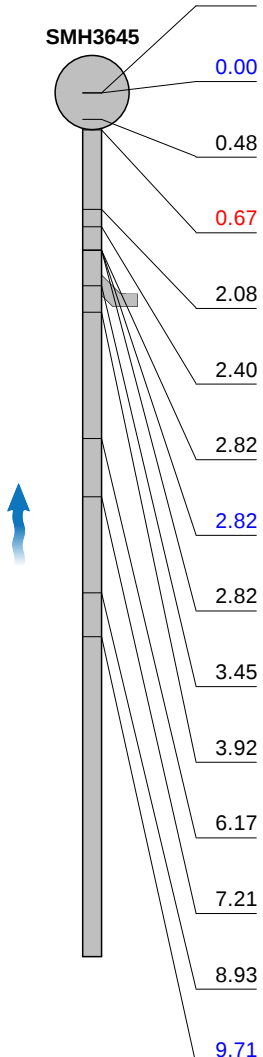
| 1:135 | [m] | Code | Observation Text | Grade |
|---|---|---|---|---|
| | 0.00 | WLT | Water level, turbid or discoloured flow, water level: 5% | |
| | 0.48 | S01 DEG | Deposits on the wall, grease, Reduction in the cross sectional area, Obstruction: <5% from 12 o'clock, Start # | |
| | 0.67 | CCW | Circumferential wall crack, width: 1mm from 12 o'clock to 12 o'clock | 1 |
| | 2.40 | JDR | Displaced joint, radial displacement, radial displacement: 5-10mm at 6 o'clock | 1 |
| | 2.82 | JDR | Displaced joint, radial displacement, radial displacement: 5-10mm at 6 o'clock | 1 |
| | 3.45 | CI | Intruding connection, magnitude of intrusion: <5% at 9 o'clock / 100mm | 2 |
| | 3.92 | RM | A mass of mostly fine roots, which has developed into an interwoven clump, Obstruction: 5-20% from 8 o'clock to 4 o'clock | 3 |
| | 6.17 | RM | A mass of mostly fine roots, which has developed into an interwoven clump, Obstruction: 5-20% from 7 o'clock to 5 o'clock | 3 |
| | 7.21 | RM | A mass of mostly fine roots, which has developed into an interwoven clump, at joint, Obstruction: 21-50% from 12 o'clock to 12 o'clock | 4 |
| | 8.93 | RF | Fine roots--a relatively small number of flexible minor roots, Obstruction: <5% from 12 o'clock to 12 o'clock | 1 |
